TEST OF A FULL-SCALE TWO-STORY STEEL X-BRBF: STRONG-AXIS INSTABILITY OF BUCKLING RESTRAINED BRACE ASSOCIATED WITH OUT-OF-PLANE BENDING OF GUSSET CONNECTIONS

ABSTRACT: This paper presents tests and finite element analyses of a two-story, buckling-restrained braced frame (BRBF) with X-bracing configuration, called X-BRBF. The BRB used in this work is composed of a core plate sandwiched by a pair of the restraining member with bolts, called a sandwiched buckling restrained brace (SBRB). The weak-axis of the SBRB core that had a rectangular plate was positioned transverse to the dual-gusset plate connection and in-plane movement of the frame. The objectives of the frame test were to evaluate: (1) the seismic performance of SBRBs with a small width-to-thickness ratio of the core plate (i.e. 3), (2) the effects of free-edge stiffeners on the gusset and BRB stability, and (3) the BRB stability associated with the lateral torsional buckling (LTB) of the beam. The two-story X-BRBF subassembly had two test phases: all gusset connections had free-edge stiffeners in Phase 1 test, and free-edge stiffeners were removed from half of gusset connections in Phase 2 test. The X-BRBF in Phase 1 test

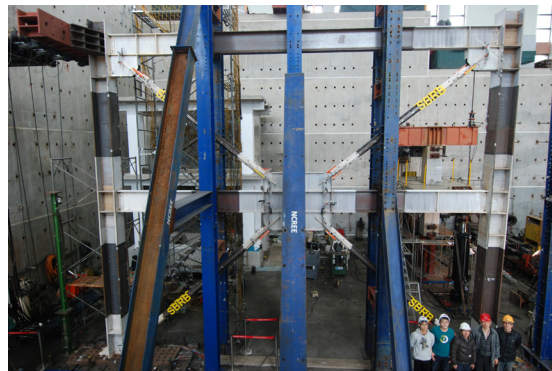
(b) Phase 1 test (1.6% second floor drift)

entire test program consisted of two testing phases. In phase 1 test, a two-story X-BRBF subassembly that had SBRB and a dual gusset configuration with free-edge stiffeners in all gusset connections was subjected to a prescribed loading protocol from *AISC Seismic Provisions* (2016) [6] to 1.6% second floor drift (Figure 1(b)). In phase 2 test, half of free-edge stiffeners of gusset plate connections were removed from gusset configuration (Figure 1(c)) and then tested using the same loading protocol to 2% second floor drift. The moment resisting frame (MRF) was tested up to 1.2% second floor drift after removing all SBRBs and gusset plates to investigate the MRF behaviour (Figure 1(d)).

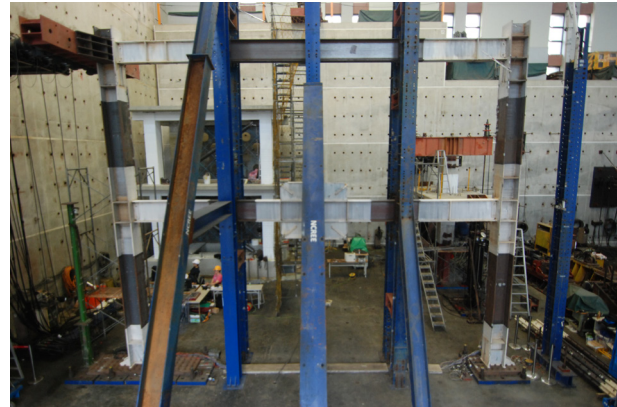
(d) MRF test (1.2% second floor drift)

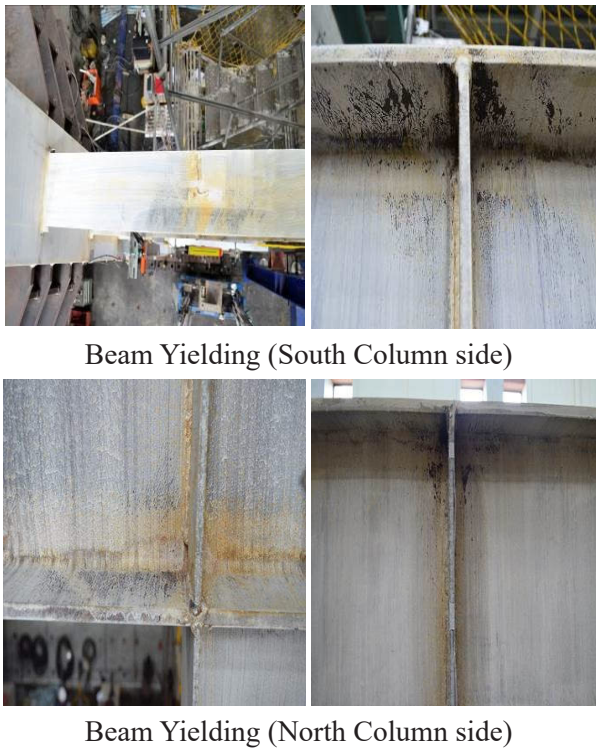
Figure 3. Observed performance in Phase 1 test (1.6% second floor drift).

Beam Yielding (South Column side)

Beam Yielding (North Column side)

The X-BRBF specimen performed well up to the second-floor drift of 1.6%, without buckling of SBRBs or gusset plates. By watching through the acrylic, no yielding was found on both ends of the core plate. All gusset plates with free-edge stiffeners did not show yielding in the test. The yielding of the specimen was observed only on the second-floor beam flange near the south column (Figure 2(a)) and north column (Figure 2(b)) at 1.6 % second-floor drift. Although beam yielding was observed, no lateral movement or buckling of the beam was visible on the second-floor. The observation showed that the core orientation of SBRBs with the weak-axis transverse to the in-plane movement of the frame is effective to improve the sudden strength drop of BRBs with weak-axis buckling.

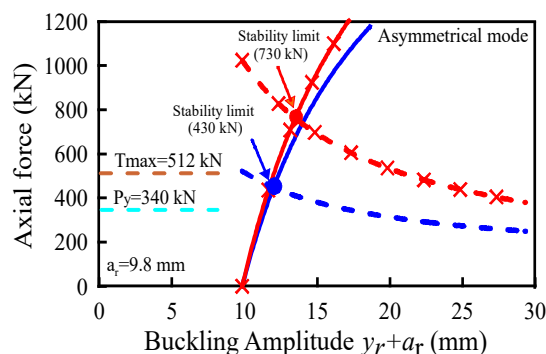
(b) Stability limit of SBRB3

Figure 6(b) shows that the stability limit axial force calculated based on Eq. (1). The value of N_{lim} for the SBRB3 about the strong-axis are lower than those about the weak-axis. The stability limit for the strong axis buckling of SBRB3 (=430 kN) are close to the buckling forces obtained from the Phase 2 test (Figure 4(c)). Moreover, the stability limit predicted for the weak axis buckling of SBRB3 (=730 kN) is much higher than that of the maximum axial load of SBRB ($T_{\text{max}} = 512$ kN), indicating that the weak axis buckling of SBRB associated with in-plane deformation of gusset plate is not possible to occur.
